Manhole Inspection Summary

Manhole # S3900_003MH

Location Address: **731 BARTLETT AVE**

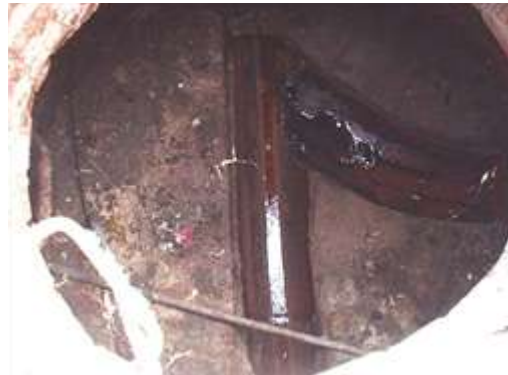
Top View

Corroded steps. Evidence of surcharge - Bench debris.

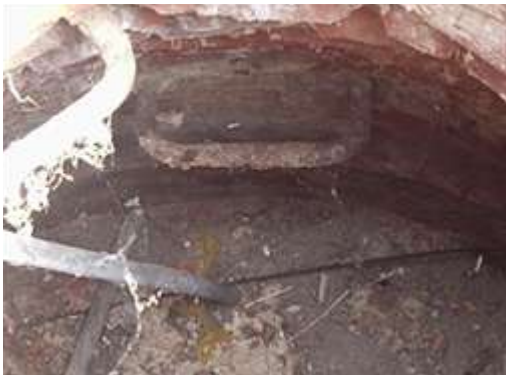
Defect

Barrel infiltration.

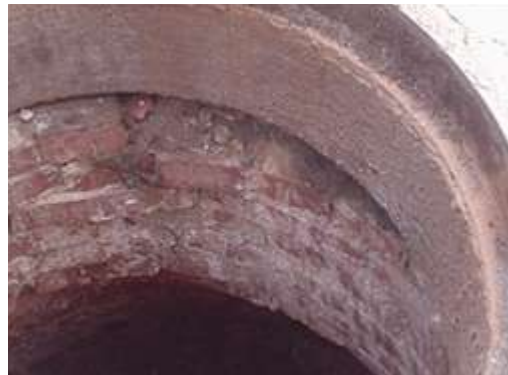
Defect

Frame leaks. Adjustment deterioration, loose brick and infiltration.

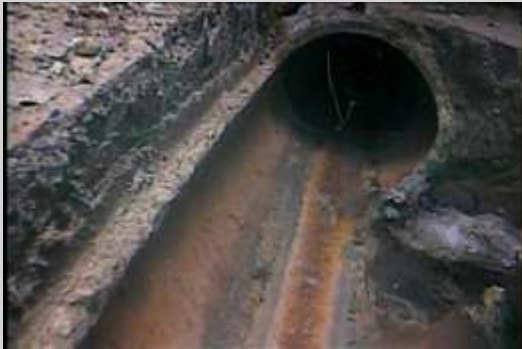
8 in. Circular Gravity Sewer Pipe Out @ 12 O'Clock

Infiltration: **Evidence** Pipe Seal Cond: **Broken**

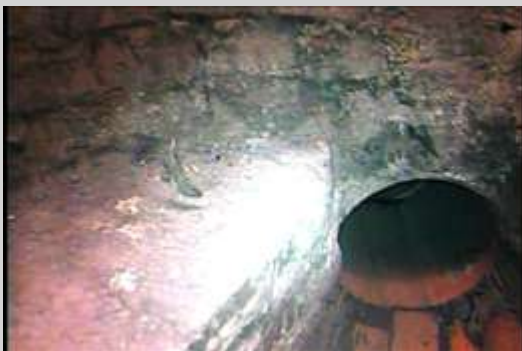
8 in. Circular Gravity Sewer Pipe In @ 3 O'Clock

Barrel deterioration and infiltration.
